Locomotive Aftertreatment - Project Updates

Steven G. Fritz, P.E.

Department of Engine and Emissions Research
Southwest Research Institute®

June 10, 2009

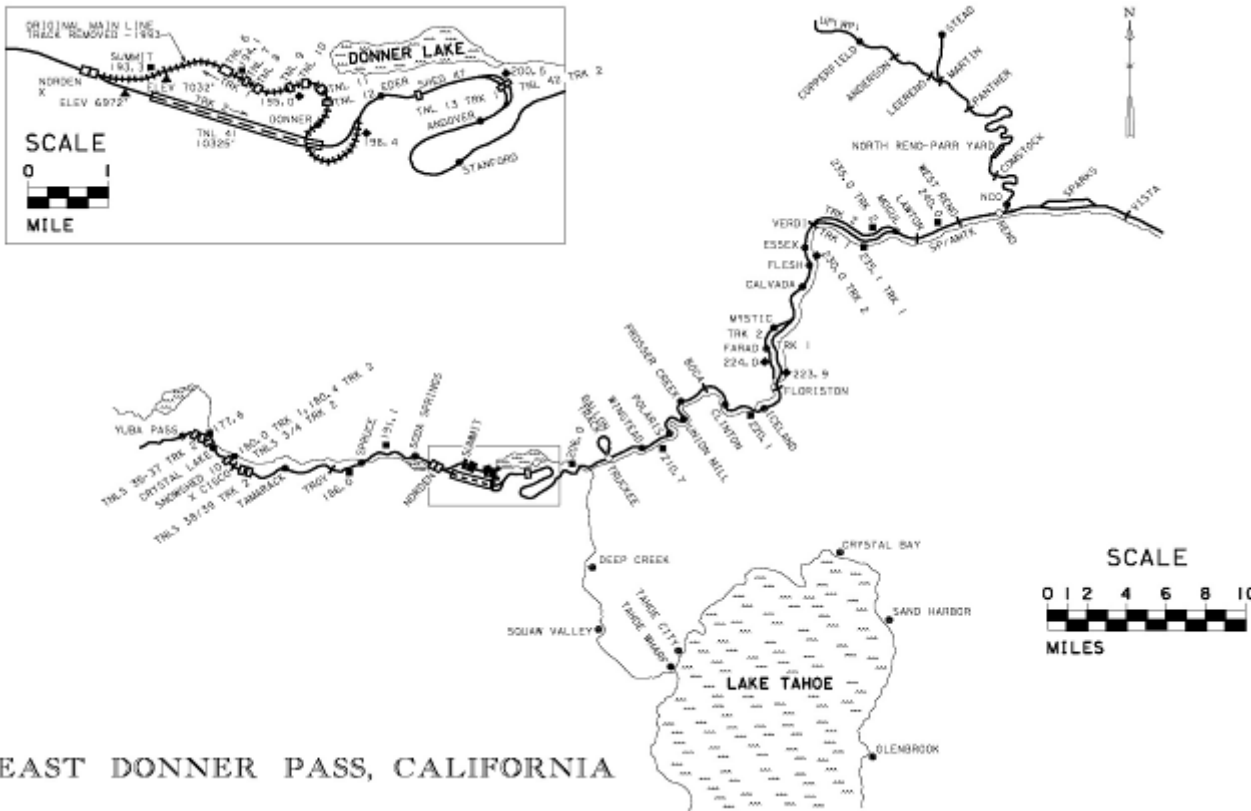
Train Test Route

- 127-mile route from Sparks, NV to Roseville, CA
 - Starting elevation of 4400' climbing to a maximum of 6890' at the west portal of Tunnel #41 near Norden CA
- Data acquisition focused on the 50 mile west-bound climb through Donner Pass in the Sierra Nevada Mountains

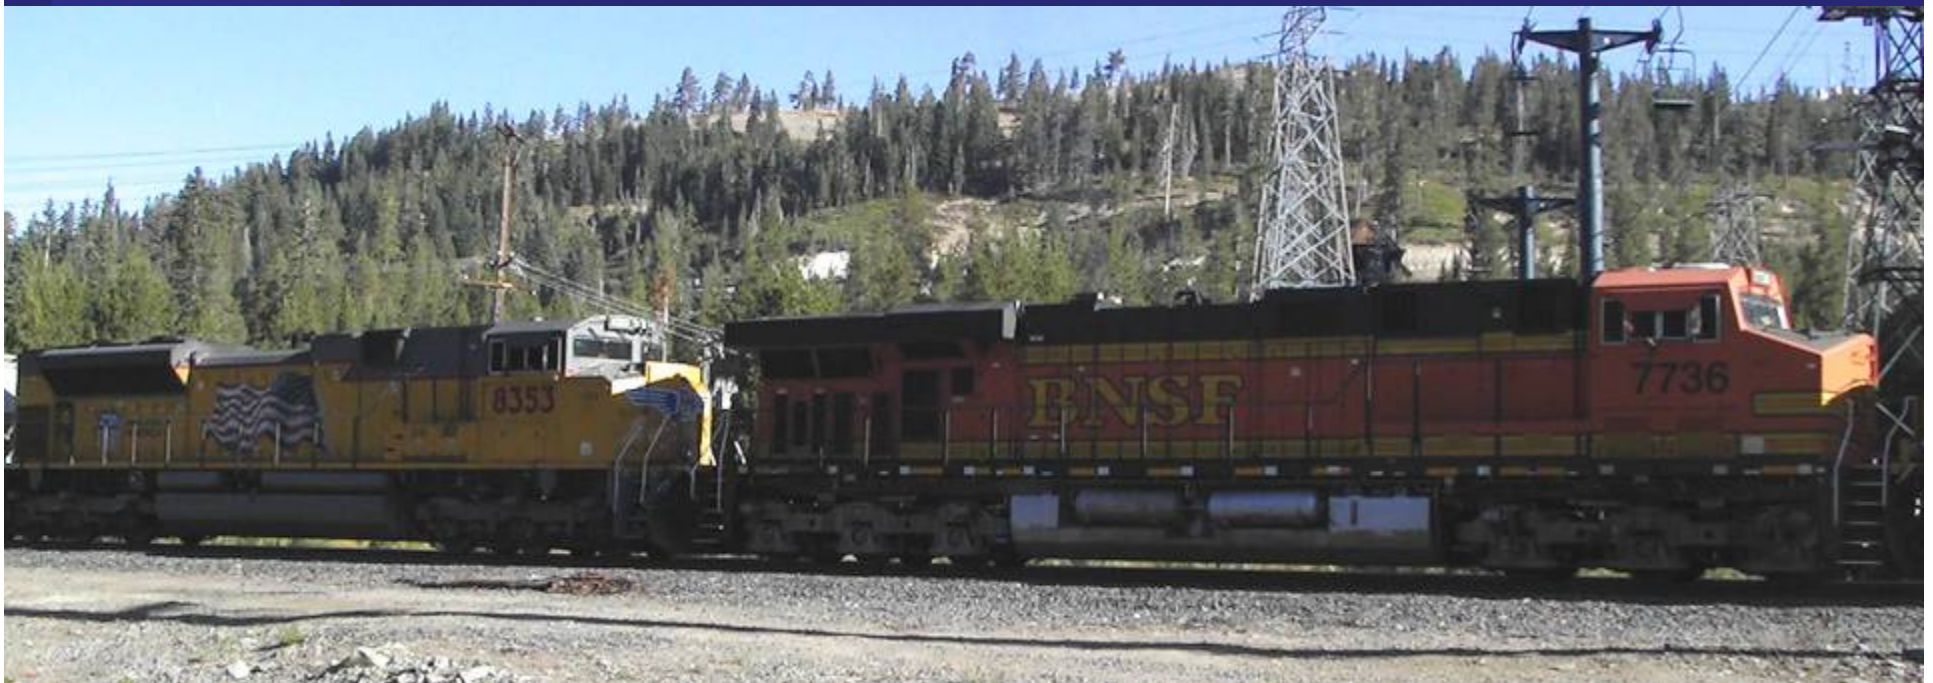
Tested Locomotives

- UP8353
 - EMD SD70ACe Locomotive
 - EMD 16-710G3C-T2
 - 3200 kW traction power
 - Tier 2 emissions
- BNSF7736
 - GE ES44DC Locomotive
 - GE GEVO V12
 - 3200 kW traction power
 - Tier 2 emissions

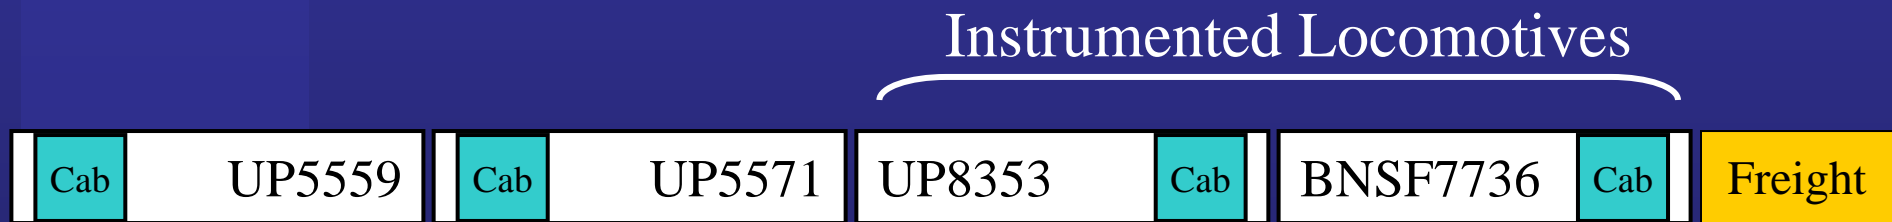
Locomotive Consist Arrangement

Direction of travel

- 62-car freight train
- 8,347 tons
- 5th locomotive at rear of train (distributed power)

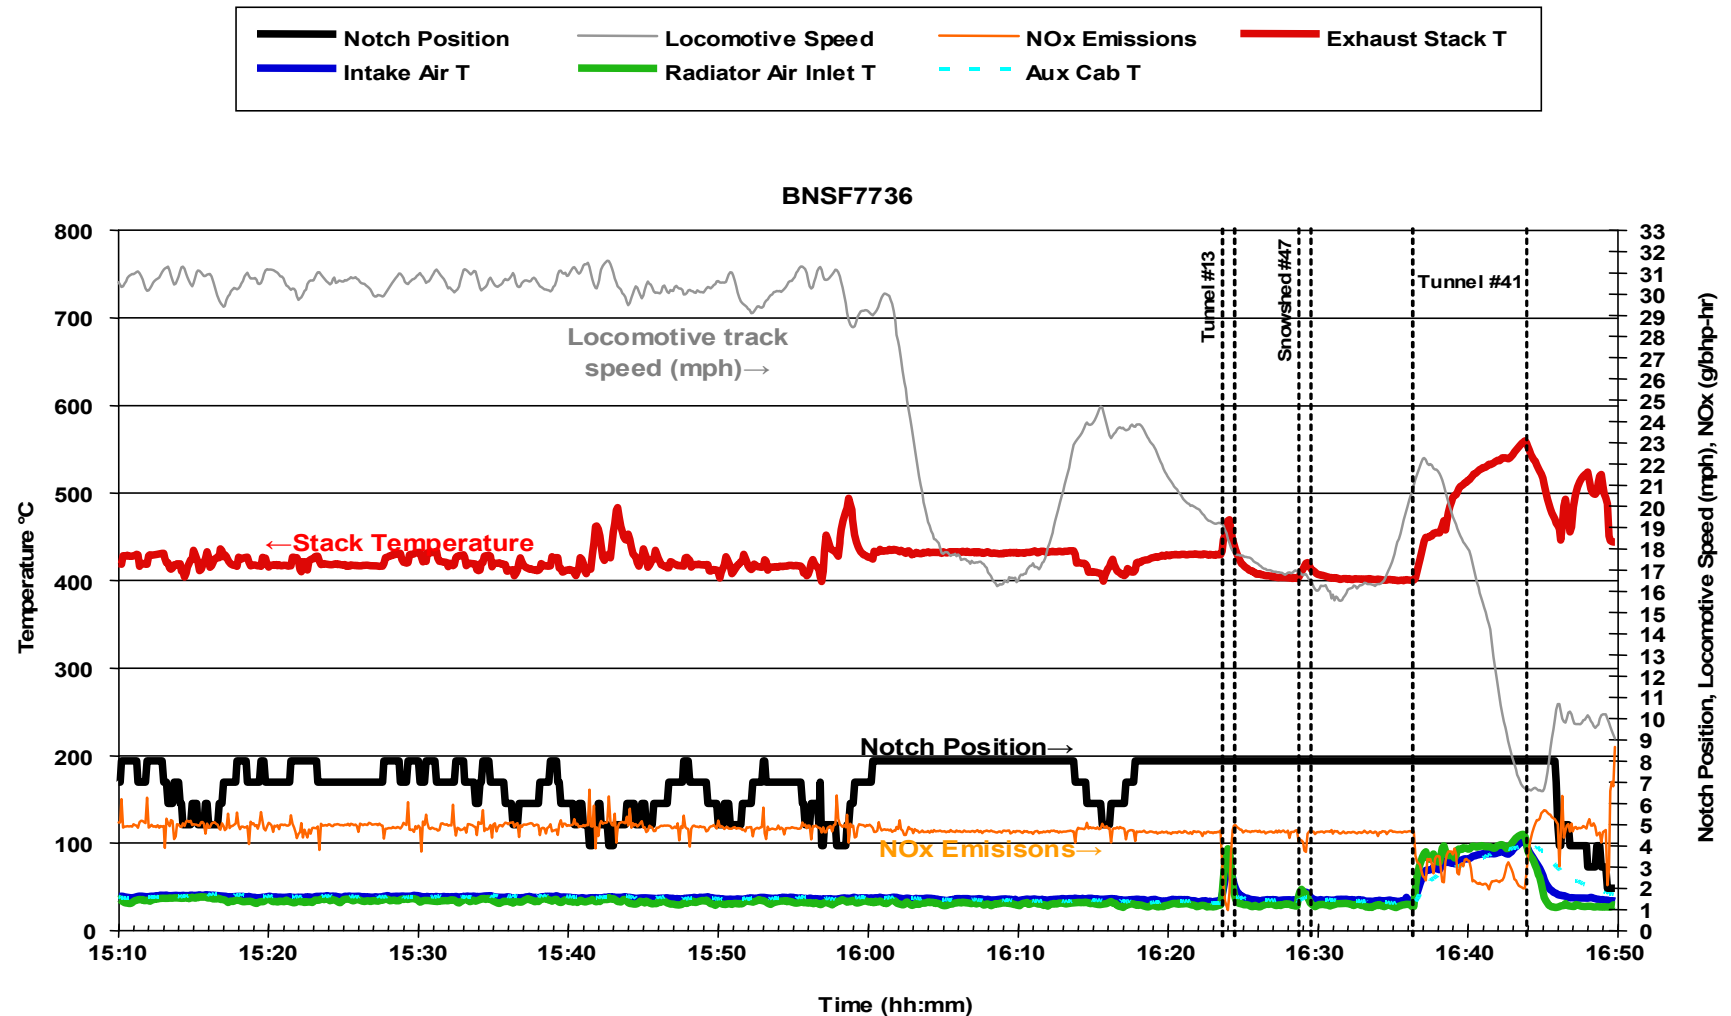
Tunnel Testing to Validate Catalyst Durability

Tier 2 GE locomotive tested at a high-altitude & through multiple tunnels (Donner Pass Norden Tunnel System)

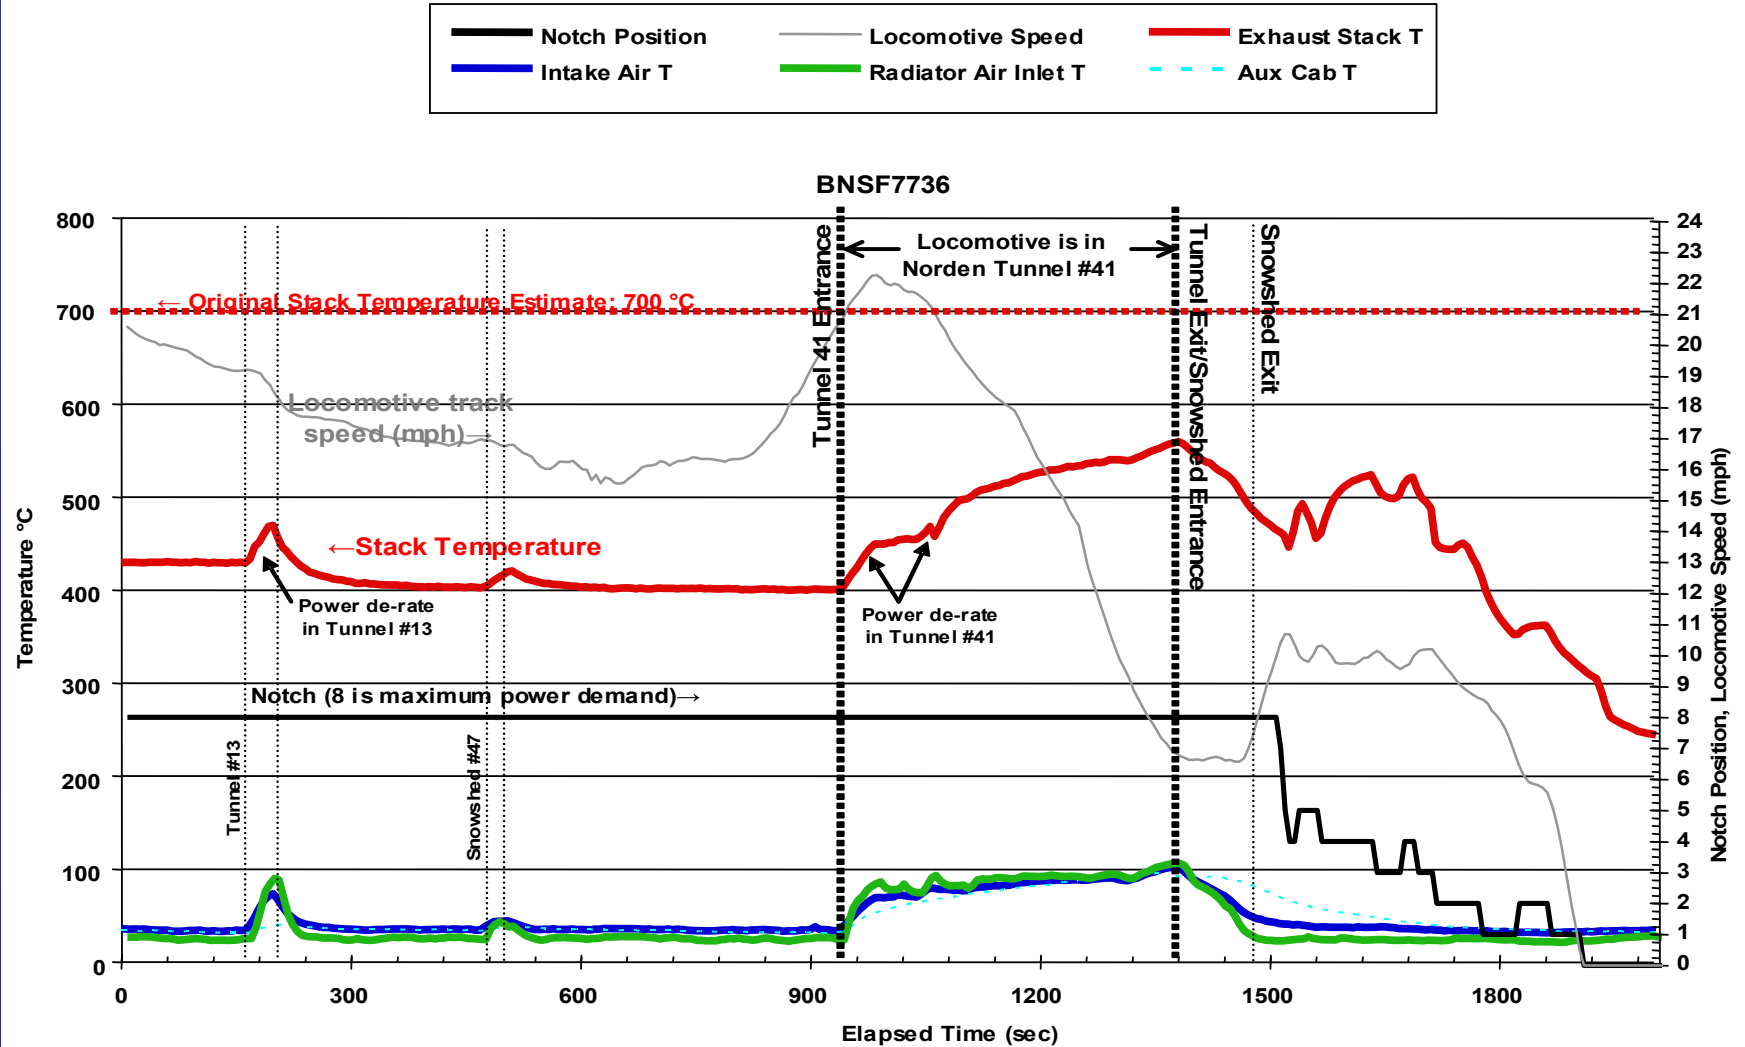
Tunnel Testing to Validate Catalyst Durability

Tier 2 GE locomotive tested at a high-altitude & through multiple tunnels
(Donner Pass Norden Tunnel System)

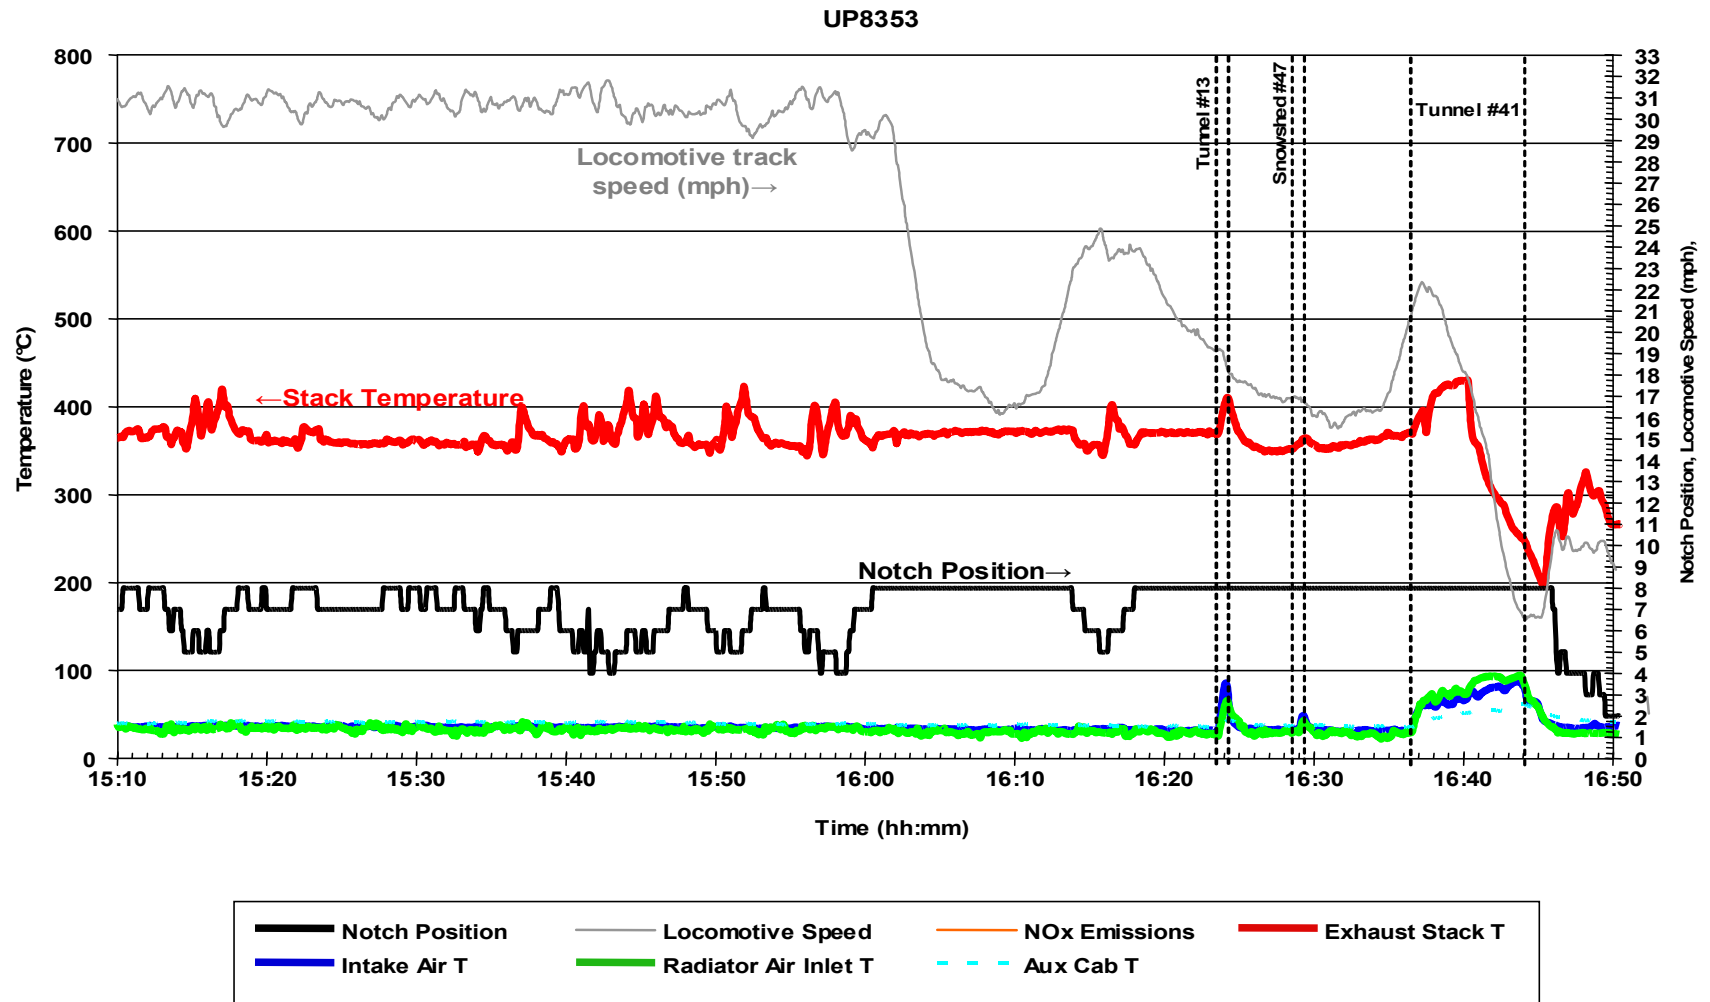
Tunnel Testing to Validate Catalyst Durability

Tier 2 EMD locomotive tested at a high-altitude & through multiple tunnels
(Donner Pass Norden Tunnel System)

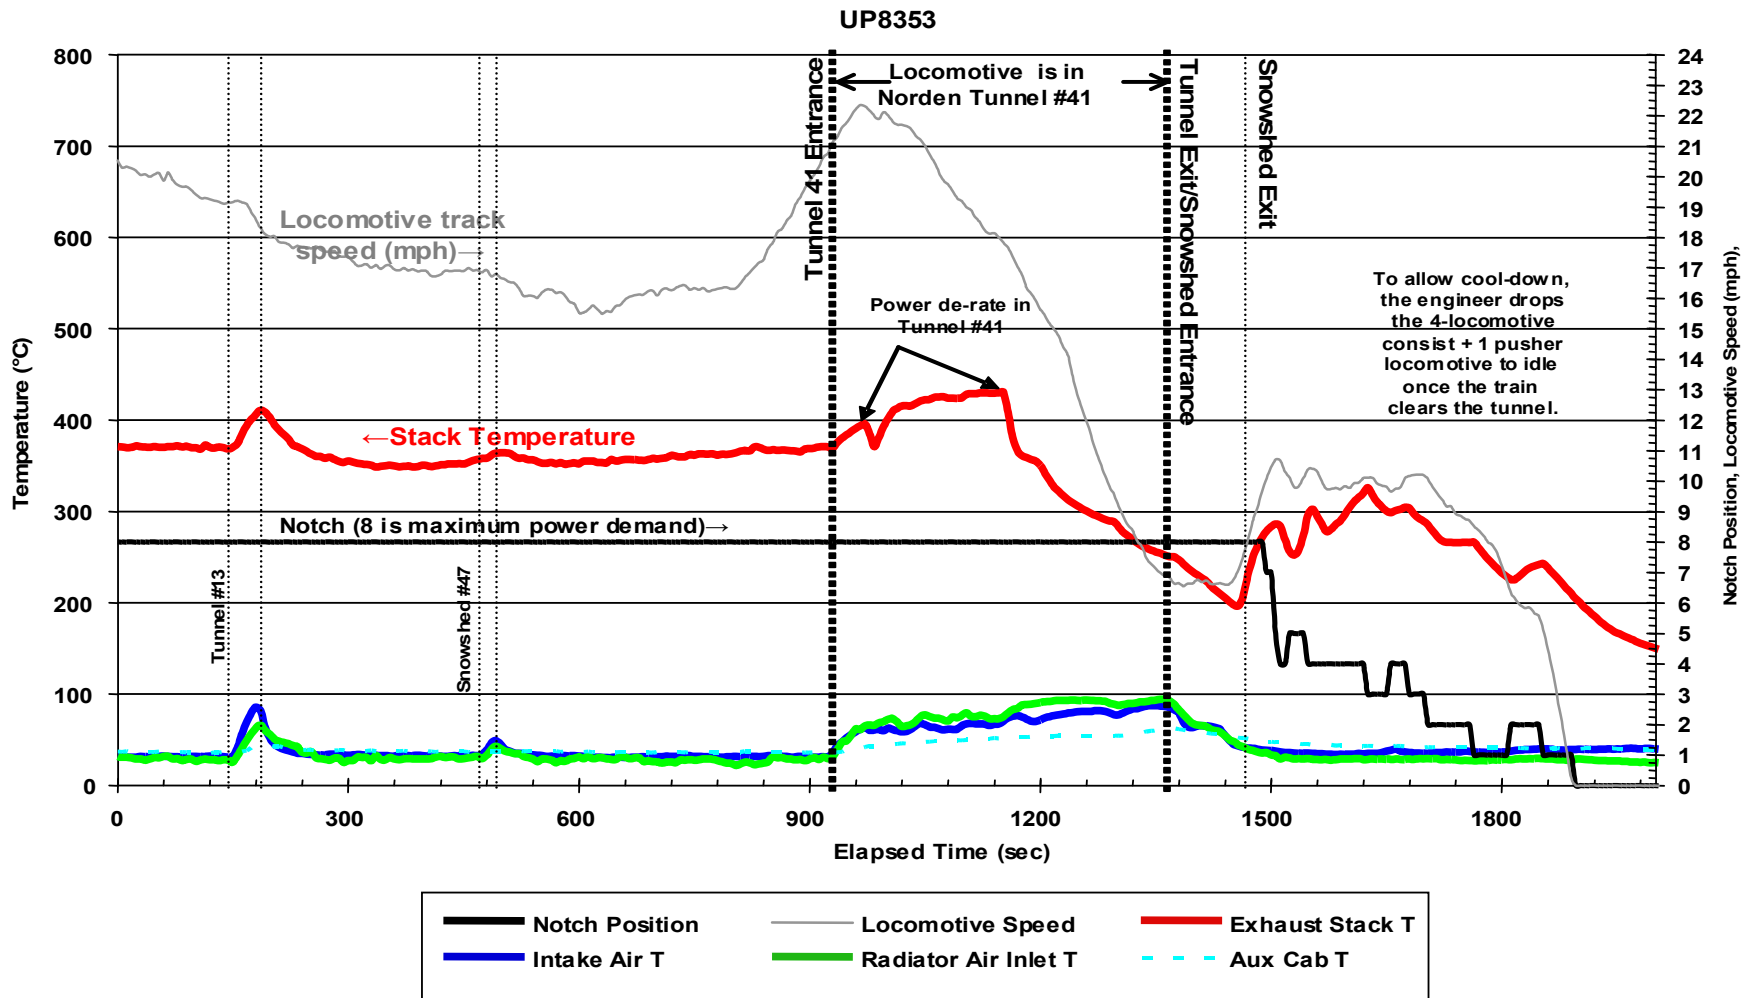
Tunnel Testing to Validate Catalyst Durability

Tier 2 EMD locomotive tested at a high-altitude & through multiple tunnels (Donner Pass Norden Tunnel System)

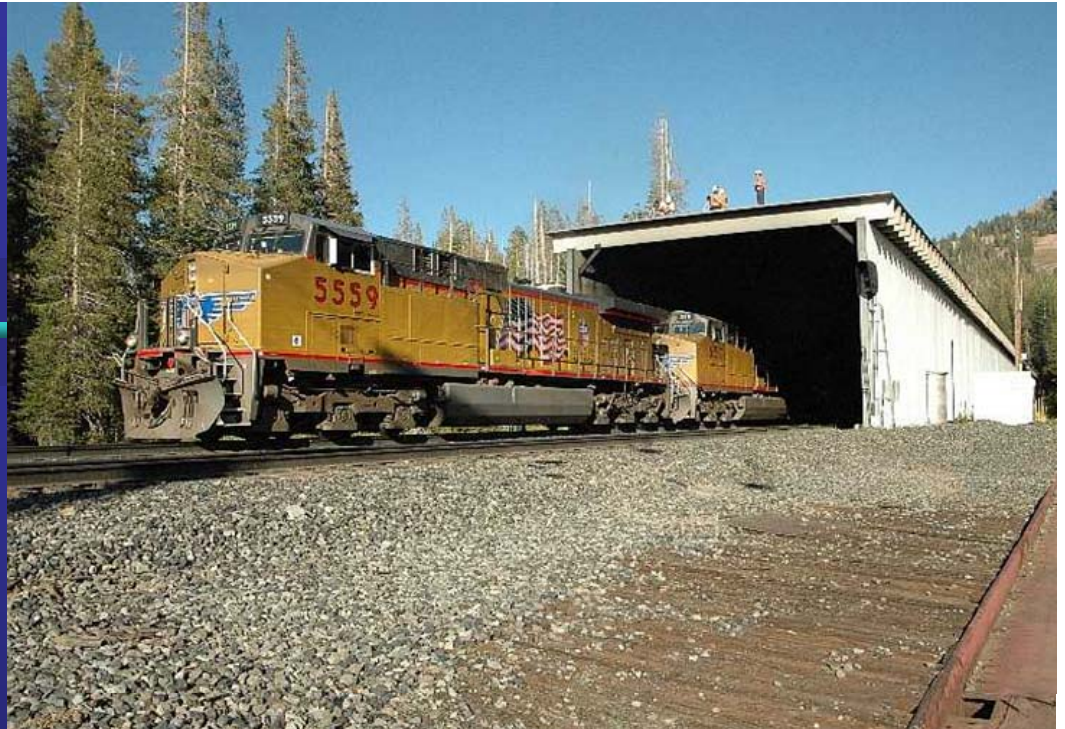
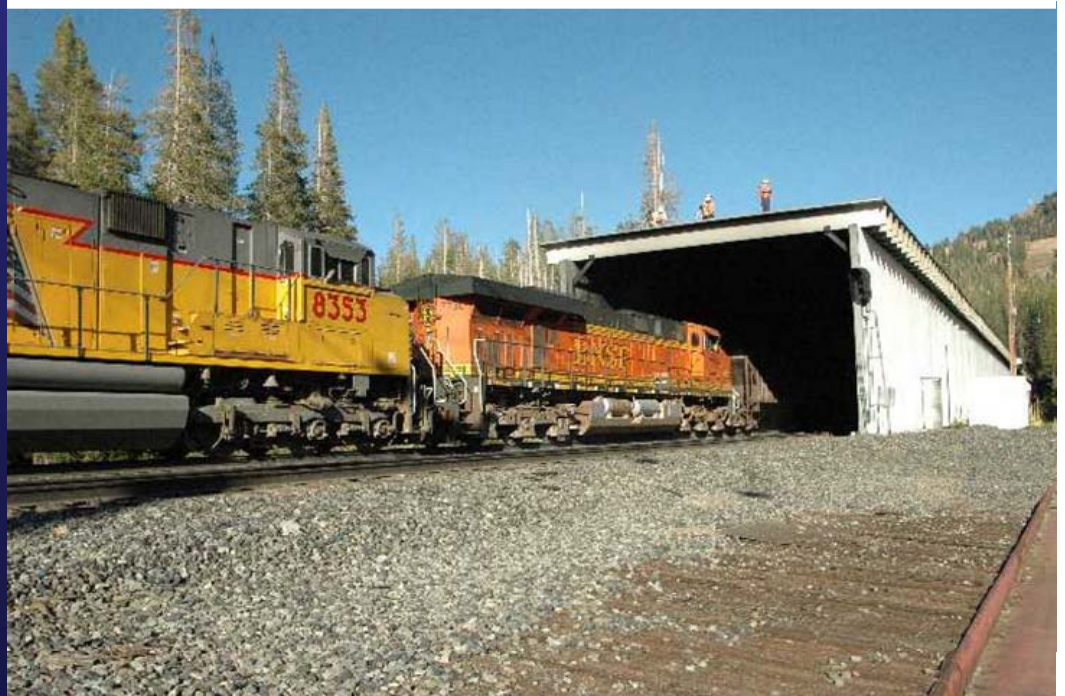
Tunnel #41 West Portal

- Significant power de-rate occurred just prior to and within Tunnel #41
- Multiple temperature-limit “alarms” had been reached
- Train was stopped to allow high-idle cool-down when clear of the tunnel
 - Ensured availability of locomotive dynamic braking for the “downhill” portion of the route

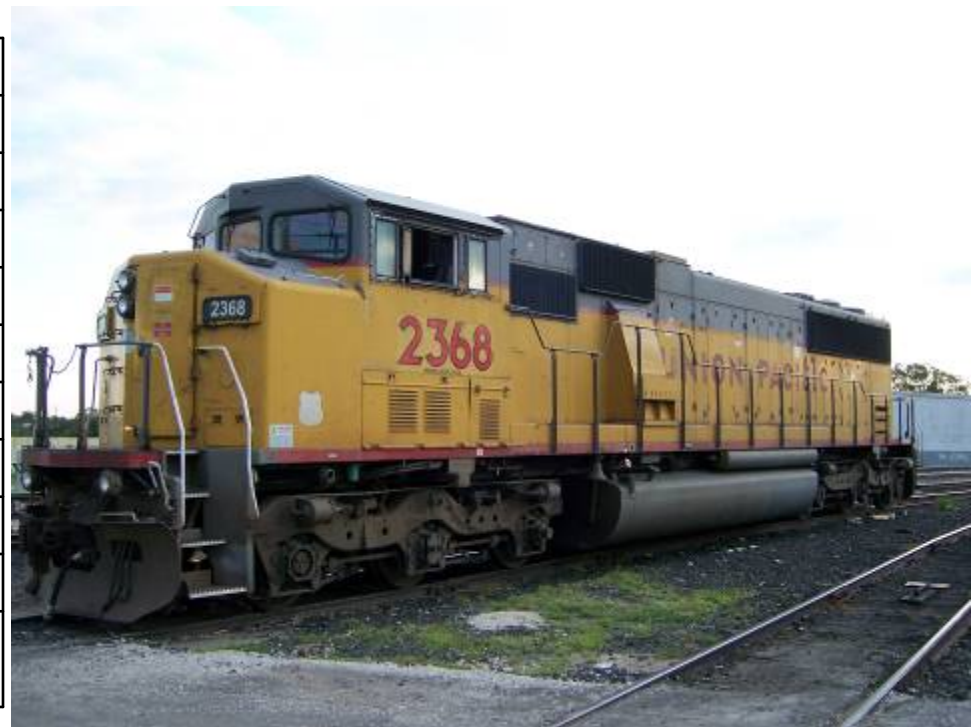
EMD SD60 Locomotive

- ★ **This Project consists of the retrofit of an experimental Diesel Oxidation Catalyst (DOC) to a Tier 0 Line-haul EMD SD60 locomotive.**
 - » **First such retrofit to a high HP freight locomotive in the U.S.**

Locomotive Number	UP 2368
Locomotive Model	EMD SD60M
Original Build Date	1989
Rebuilt to Tier 0	April 2006
ZTR Smart Start installed	April 2006
Engine Model	EMD 16-710-G3A
Rated Traction Power	3800 hp
Displacement/Cylinder	710 in ³
Compression ratio	16.0:1
Rated engine speed	904 rpm
Fuel Injection	Mechanical Unit Injectors

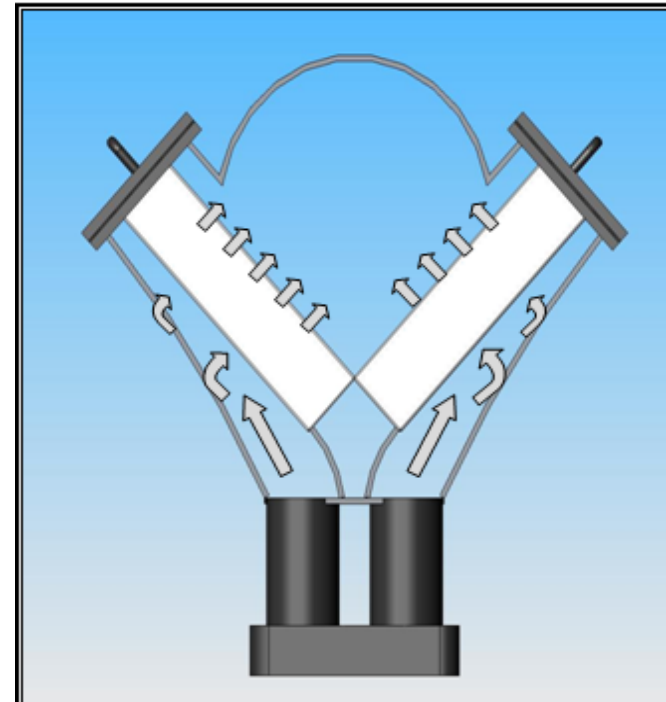
First Attempt
“breathing” limitations

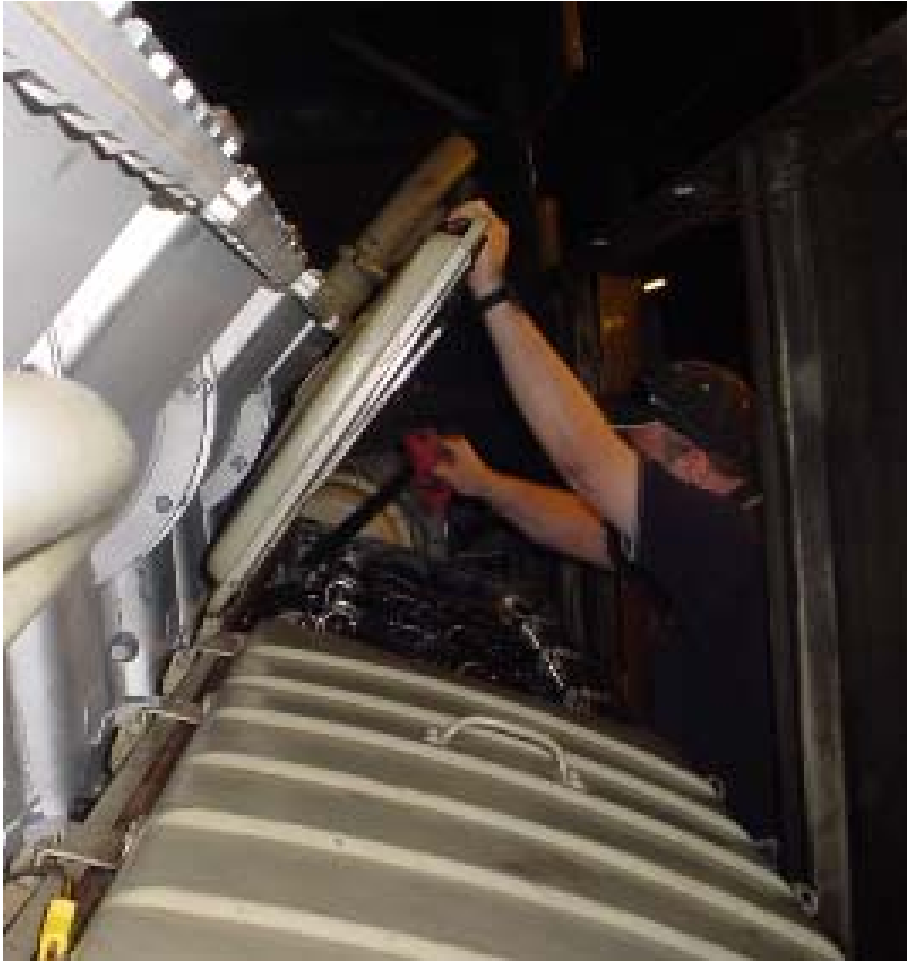
Gen 2 Design

Pre-Turbine DOC on an EMD SD60

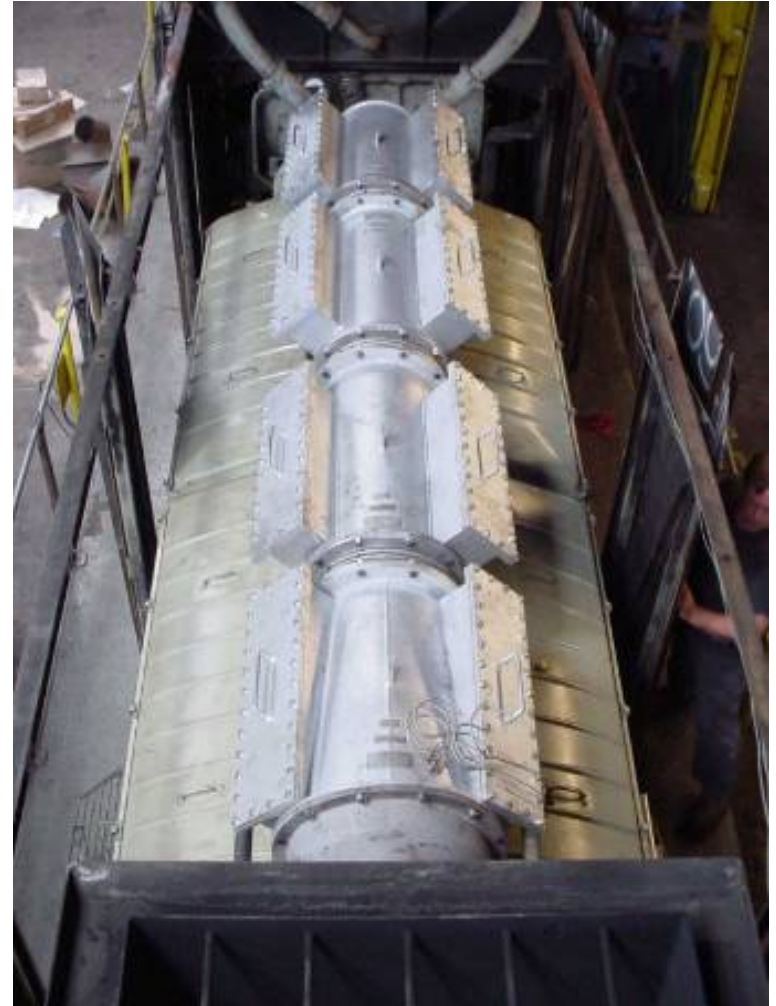
**Power Assembly Service
Access Remains**

With Roof off of locomotive

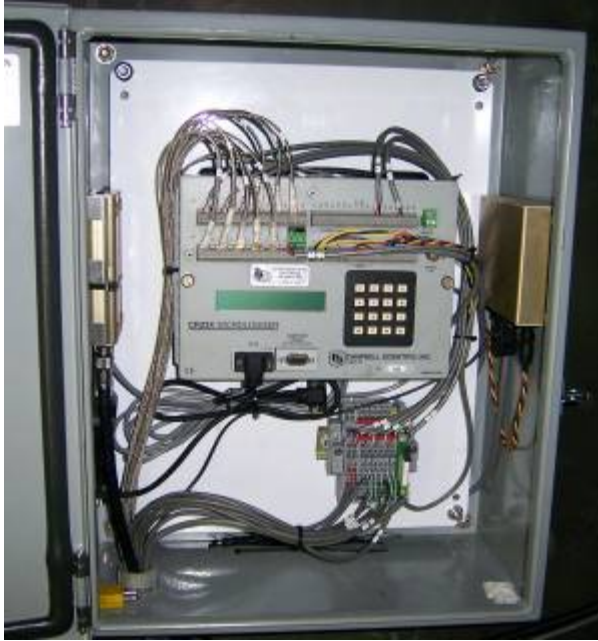
On-Board Datalogger

- * UP2368 instrumented with data logging system
- * Continually monitors and records operational parameters during revenue service
- * Cellular phone package used to monitor and download data via internet
- * GPS equipped to track movement

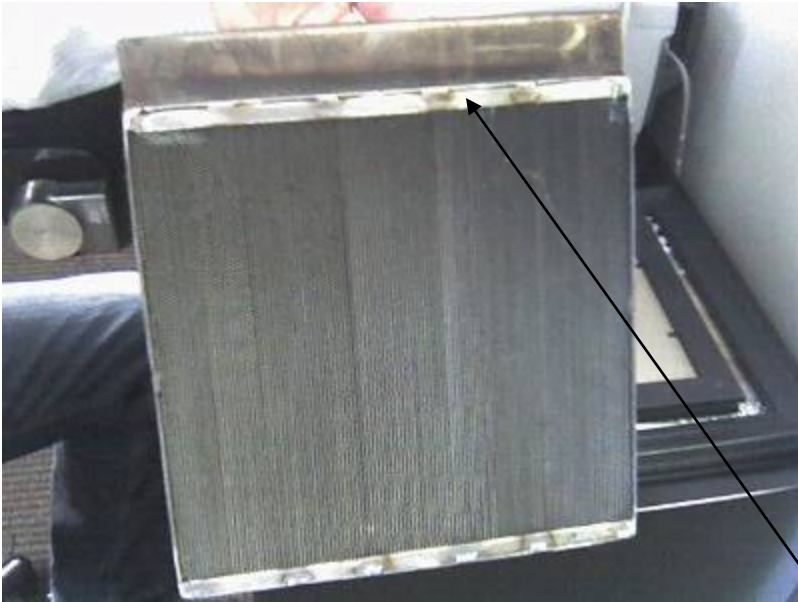
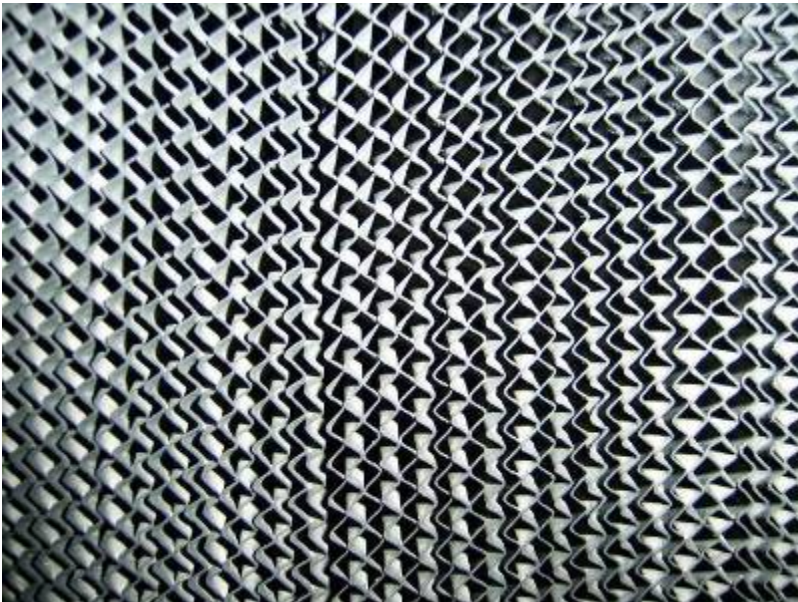
Gen 2 Durability

- * UP 2368 entered revenue service in October 2006
- * Three-month Inspection revealed a minor mechanical problem with the catalyst elements that was quickly repaired
 - » Catalyst was Clean and Dry
- * Locomotive Returned to SwRI in April'07 for Second Inspection and Six-month Emissions Test
 - » Catalyst was Clean and Dry
 - » However, mechanical failures of catalyst frame
 - » Pulled all oxycat elements, returned loco to service w/o elements
 - » Miratech redesigned catalyst frame, and reinstalled at Los Angeles in June'07.

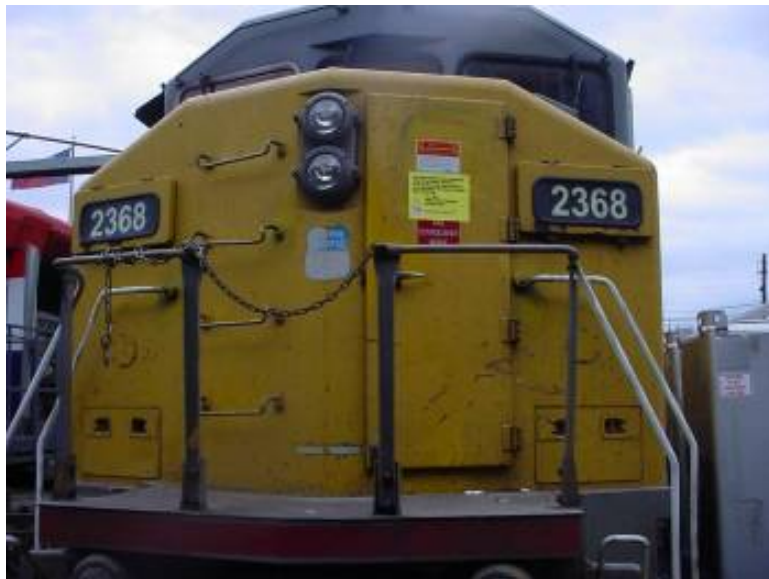
- * Replacement DOC elements installed in LA in JUN'07
 - » 1,163 hours on new elements as of 07-OCT-2007
- * 08-OCT-2007
 - » UP in West Colton reported low power
 - » Shop contacted Mike Iden per sticker instructions

**THIS ENGINE EQUIPPED WITH EXPERIMENTAL
CATALYSTS IN EXHAUST MANIFOLDS.
DO NOT REMOVE MANIFOLDS OR PERFORM
ANY MAINTENANCE ON MANIFOLDS WITHOUT
FIRST CONTACTING:**

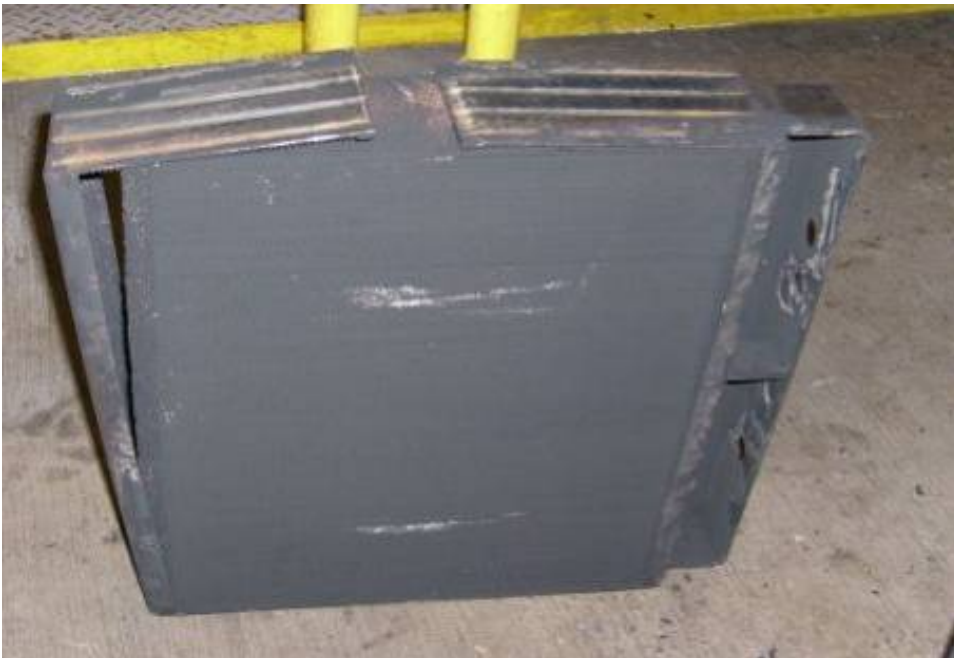
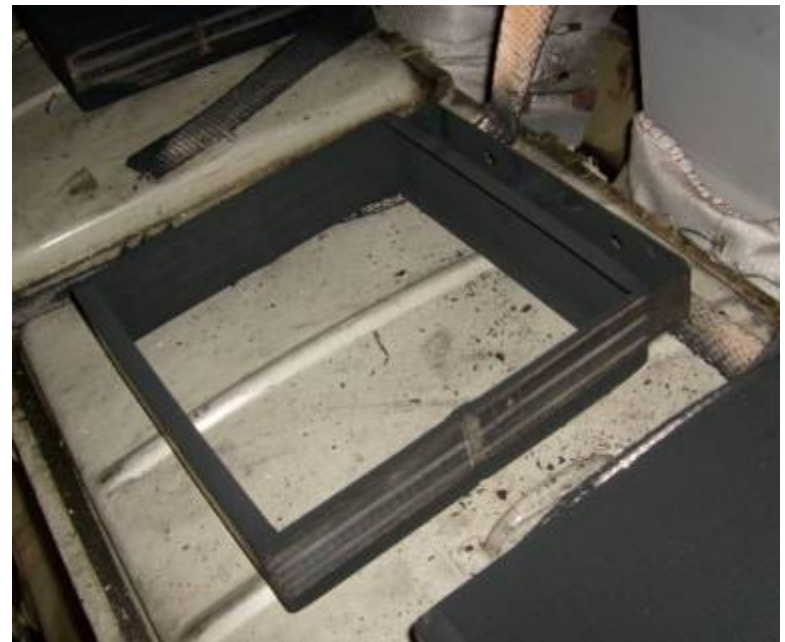
Another Iteration on Catalyst Elements

- * UPRR inspection in Oct-07 revealed turbo screen plugged with DOC debris
- * Miratech field service dispatched to inspect & remove DOC elements
 - » 2 of 16 catalyst elements damaged
- * All 16 catalyst elements removed and sent to Miratech for failure analysis
 - » Locomotive continued to operate in revenue service w/o DOC elements.
- * Miratech developed V-Cat design

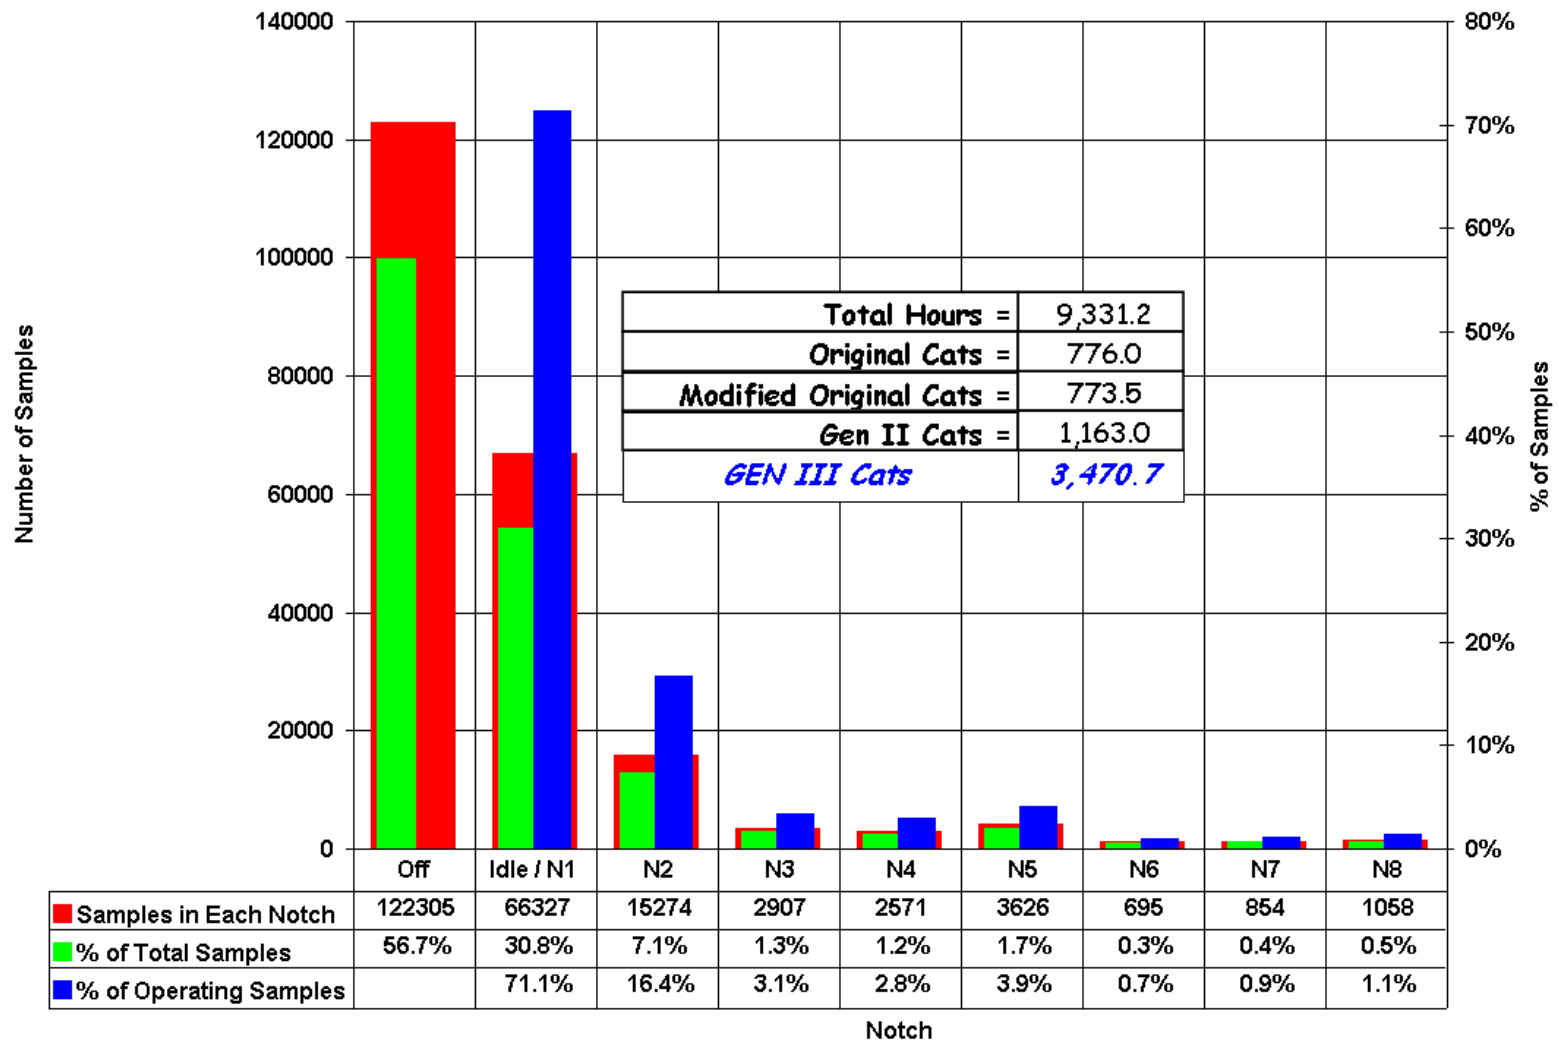
UP2368 Duty-Cycle & Hour Summary

As of May 31, 2009

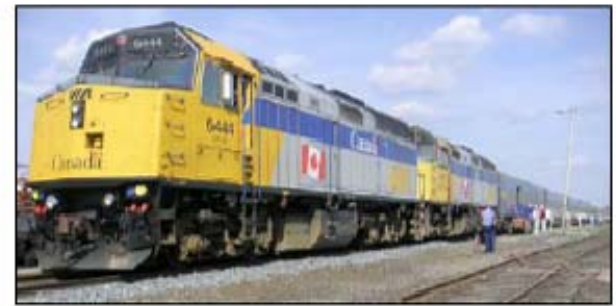
– VIA Rail

- EMD F40PH - 16-645 (3,000 Hp)
- Demonstration started - 4/08
- ~ 4,000 hrs

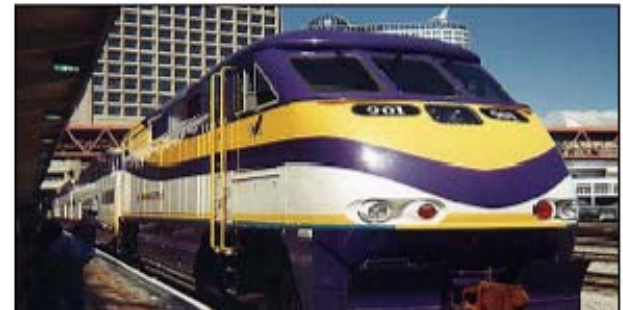
– West Coast Express

- EMD F59PH – 12-710 (3,000 Hp)
- Demonstration started - 11/08

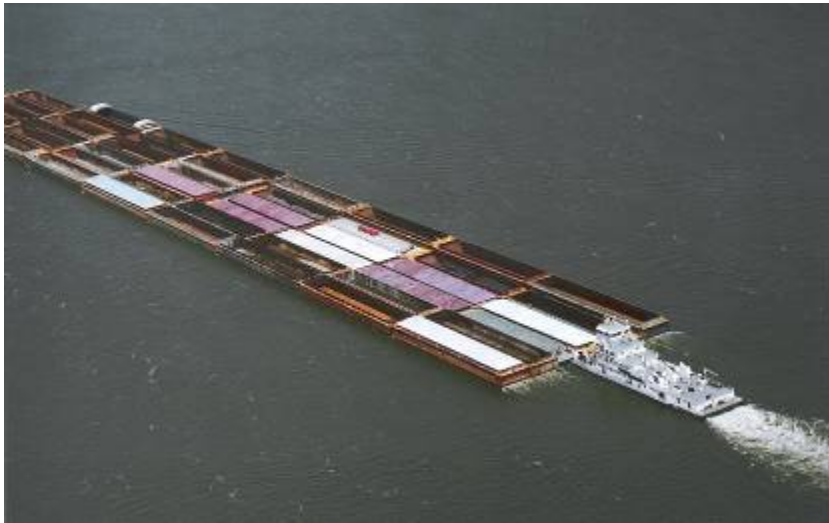
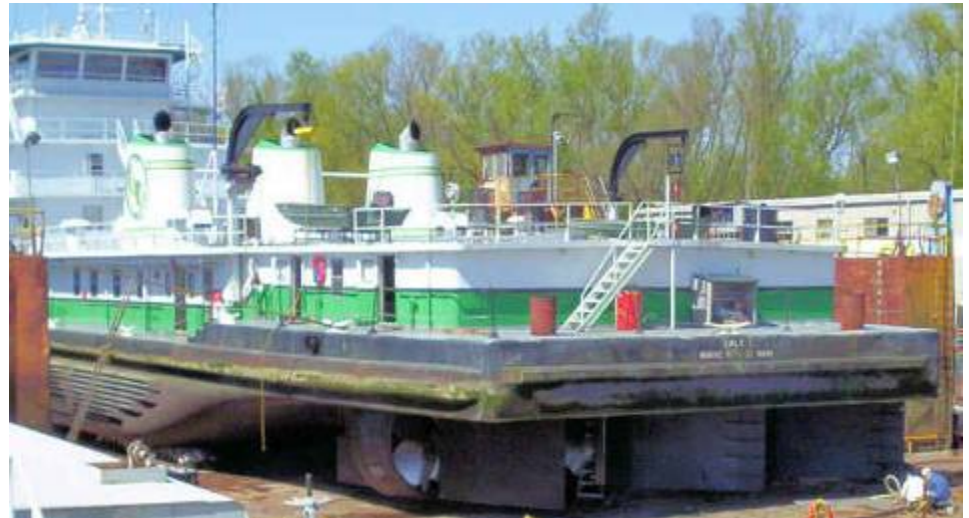
Ingram Barge – M/V Gale C

Length 200 feet - Width 50 feet - Triple Screw GM 12-710G-7B 9180 HP
Built 1973 by St. Louis Ship, St. Louis, MO
Repowered 1999

- * 3 x 3,000 HP EMD 12-710G engines
- * Miratech V-Cat installed April 2009 on center engine
- * Currently at ~1,000 hours – no noticeable change in engine parameters
- * First inspection due in September, 2009

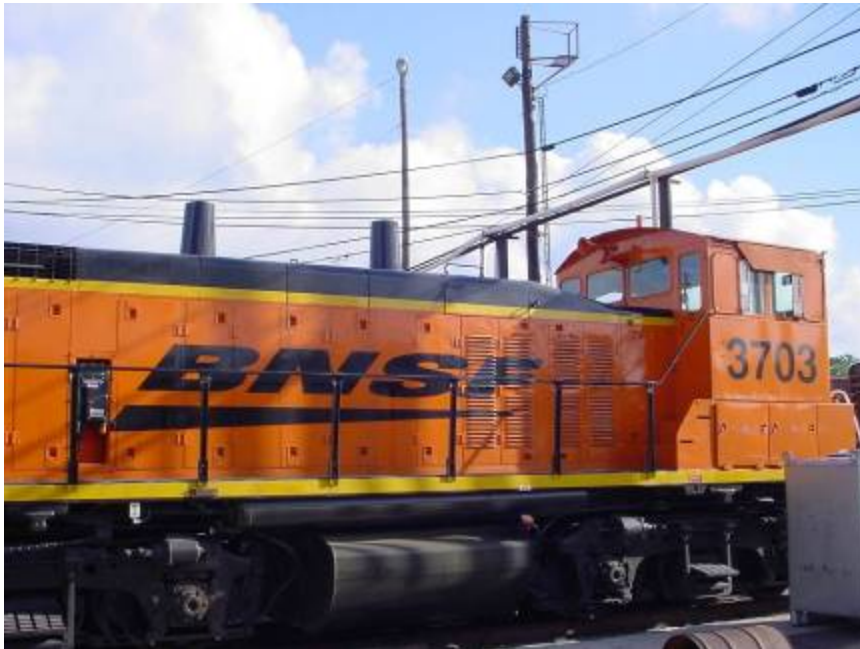
Phase 2 – Field Implementation

BNSF3703

- Released from overhaul on June 2006
- Equipped with idle reduction system & APU

UPY1378

- Overhauled in Fall 2005
- Routed to SwRI in Feb. 2006 for DPF mounting design concept meeting
- Equipped with idle reduction system

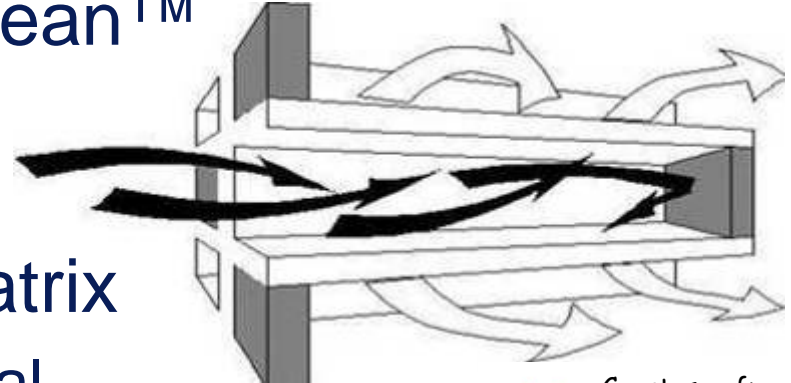
DPF Selected for Demonstration

- * DPF selected was a MobiClean™
 - » Wall flow filter
 - » High efficiency
- * Each DPF has 3X4 brick matrix
 - » Extended maintenance interval
